Infrared Analysis for 13 Elm Street, Anywhere, Indiana

Problems with thermal comfort, and musty odor in closet

Inspection Summary

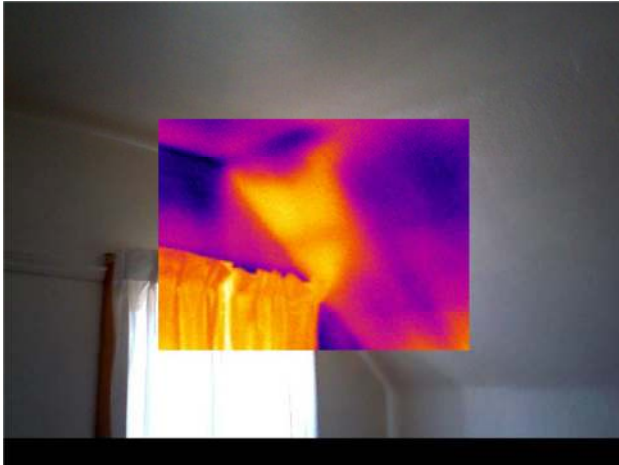
IR000293.IS2

Angled portions of the ceiling in the 2nd story show insulation deficiencies. These areas in older homes can be problematic to insulate due to the width of existing rafter/roof structure. There is simply not enough space to insulate. However, since surrounding areas show comparatively little thermal transfer to the interior surfaces, it should be assumed that insulation improvements in these areas are possible and feasible. Additional photos are included below in other areas of the 2nd story; the same discussion applies to these areas as well.

Insulation deficiencies were identified in many areas of angled walls in the 2nd story. These areas are problematic to insulate in older homes due to the width of native rafter used during construction. Sometimes, the most feasible solution is to install extruded polystyrene on the interior surfaces and to drywall over the top. This takes a small amount of space from the interior area. An alternative is to remove the shingles and to install insulation designed for roof applications, over the roof sheathing before installing a new layer of shingles. Unfortunately, rafter width places limitations on the amount of insulation that can be installed in ceilings.

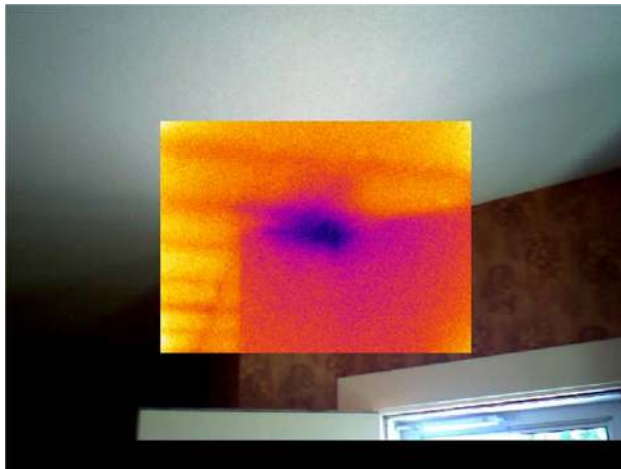
IR000305.IS2

The image below was taken in the southwest corner of the sitting room. This temperature anomaly was colder than the surrounding material, and was confirmed with radiometric moisture sensing equipment to be wet. Further inspection of the exterior found flashings to be defective above the bay area causing water leakage.

The bay area should be re-flashed and reroofed to prevent further moisture penetration.

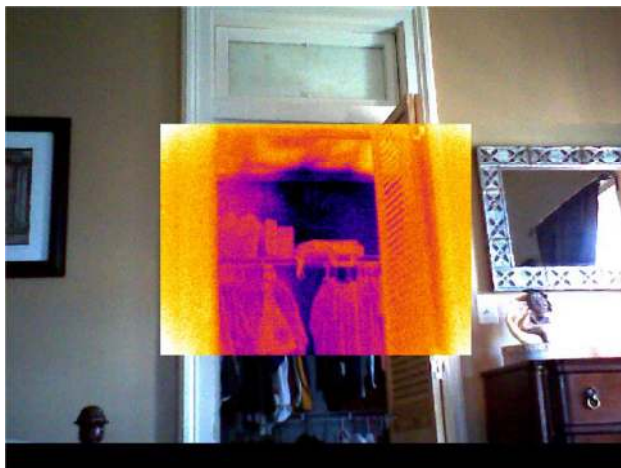
IR000307.IS2

The client has experienced moldy/musty odors in the bedroom closet. A temperature anomaly was found in the back of the closet. This temperature anomaly was colder than the surrounding material, and was confirmed with radiometric moisture sensing equipment to be wet. Further investigation revealed an old brick chimney on the back side of this wall. The chimney flashings were found to be defective, and the chimney was without a rain cap.

The chimney should be re-flashed and a rain cap should be installed on the chimney to prevent leakage.

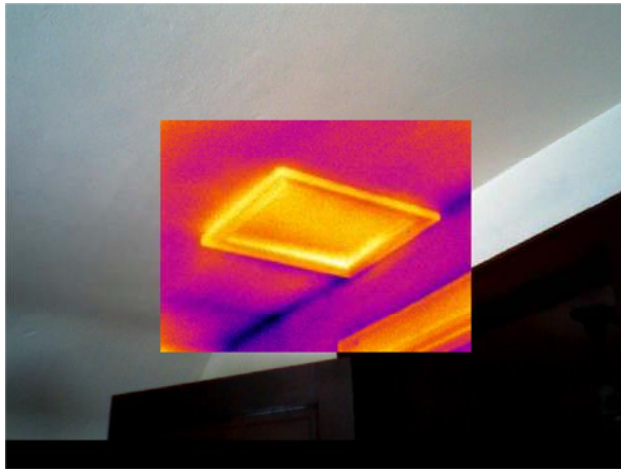
The image below shows an attic scuttle (access) in the 2nd story. A thermal scan shows this access to be inadequately insulated and unsealed. Stack effect as well as thermal transfer can occur in this area.
